# HIGHWAY RESEARCH RECORD

Number | Design of  
346 | Sign Supports and Structures

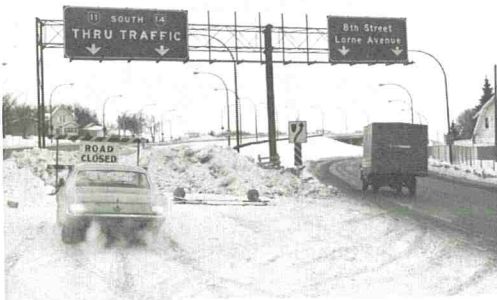
Figure 1. "Old style" overhead sign structure.

The truss configuration was, at one time, almost a universal choice for all but very short-span highway bridges. It became recognized that this type of structure was not aesthetically pleasing. The modern welded girder and prestressed concrete long-span structures were developed to replace the truss. The resulting structures were more slender and presented a solid profile. Deflection and span-depth-ratio limitations continue in most present day highway bridge design specifications as an impediment to further improvement. These rules are rather arbitrary and, while they may have served suitably in the past, it is now recognized that relaxation is possible by means of more liberal regulations (2). Similar changes can be applied to overhead sign structures resulting in greater simplicity and improved appearance. An example of where this has been done is shown in Figure 2.

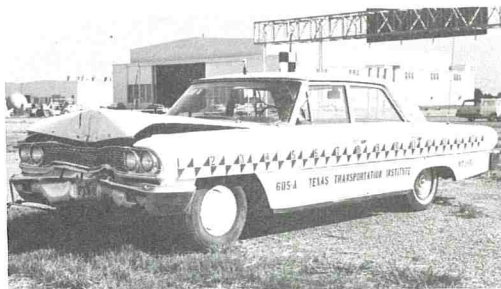
Figure 3. Vehicle after Test A.
